Heritage Conservation Plan

Holy Eucharist Cathedral - 501 4 Avenue - New Westminster, BC

Elana Zysblat, CAHP - heritage consultant - Ance Building Services

December 2021

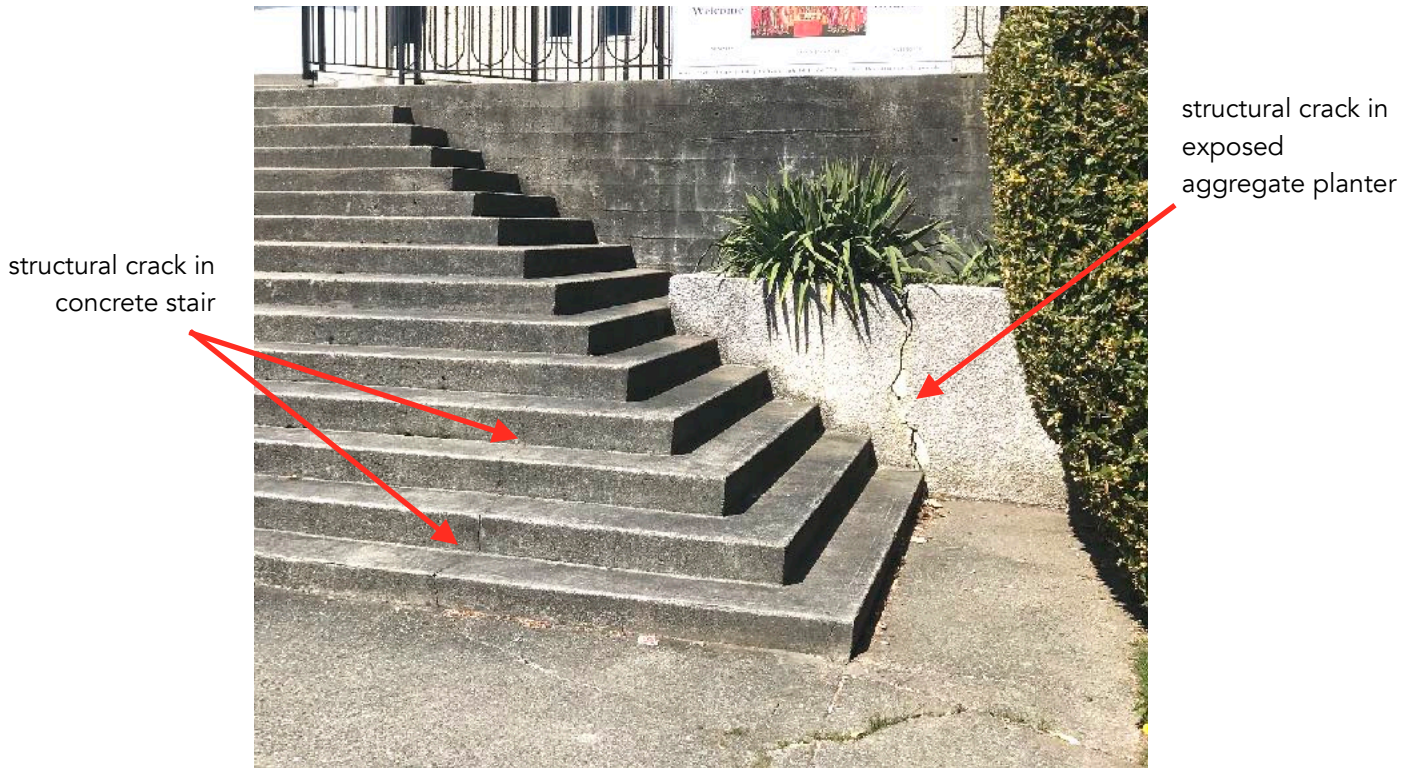
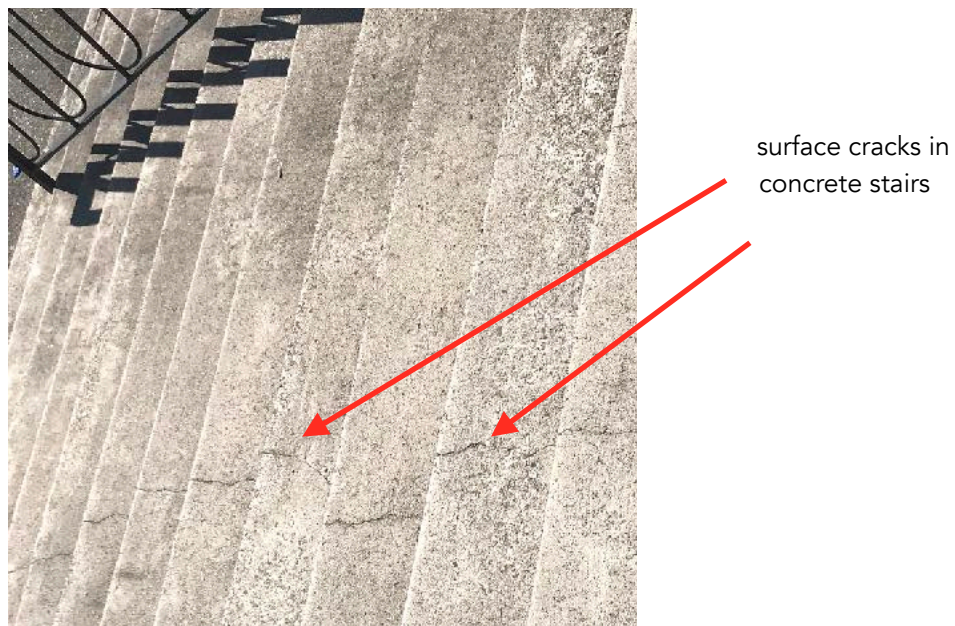
Front stairs and entrance podium

The original poured concrete stairs and hollow podium, with exposed aggregate end walls and planters, are in fair to good condition, but exhibiting wear as well as some cracks - both structural cracks and surface cracks.

Reconstruct the podium and grand stair in their current dimensions and 1960s finishes while adapting the interior of the large hollow podium to a finished, useable space (in this case an Accessible entrance and lobby to the church hall). The only proposed change to the stair and podium design would be the elimination of the final three stairs (circled in the existing photo, right) to the church doors, which would eliminate another Accessibility obstacle, making the walkway connecting the new mixed-use building to the now completely level church podium an Accessible route to both buildings. This rebuilding opportunity also eliminates the need to repair the many structural and surface cracks on the existing concrete structure.

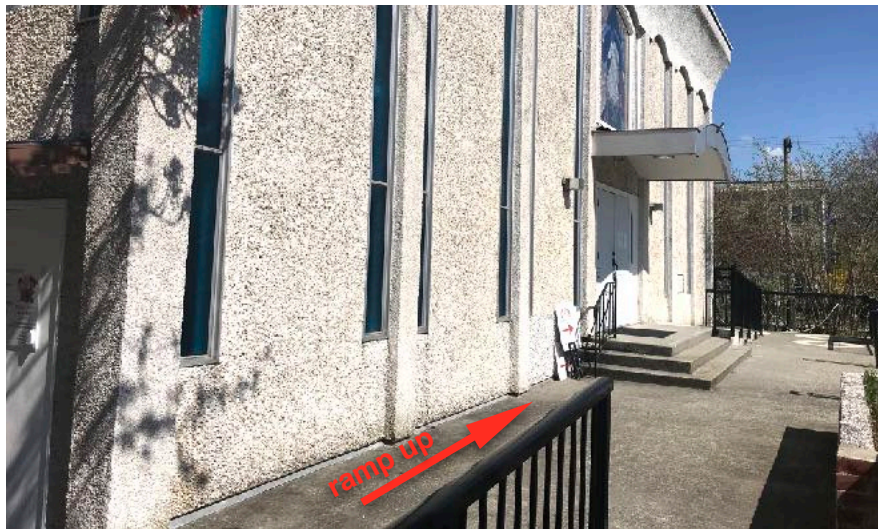
Although the grand entrance and stairs are valued as a prominent feature of the historic place, not all patrons are capable of ascending 18 steps up to the entrance doors (15 stairs plus another 3 from the podium). A poured concrete accessibility ramp which leads from the parking lot to the top of the podium, was installed in 2017 to mitigate this issue, but it falls short of providing fully non-ambulant access to either the church or hall. After ascending the ramp to the church entrance podium, an additional three exterior stairs still need to be climbed, and, although the hall entrance doors are Accessible from the parking lot, once inside, patrons must descend an additional dozen to the hall (basement) level itself. Given the building's large, diverse parish of all ages and abilities, and its robust community rental program, the lack of adequate Accessibility of the current stairs and ramp results in the historic place not being accessible to non-ambulant patrons.

Photo showing the last section of the 'accessibility ramp' arriving at the entrance podium but more stairs at the church entrance doors are left to tackle.

Rebuild the entrance podium and stairs to finally resolve the ongoing challenge of the existing lack of Accessibility to both church and hall, increasing and improving both the religious and secular uses of the historic place. In this new configuration, which will not be perceived as different from the street, the basement level hall will now be Accessible at street level from an entrance below the podium (1) and the church will be Accessible via elevators in the new mixed-use building next door (2) that lead onto the reconstructed entrance podium.

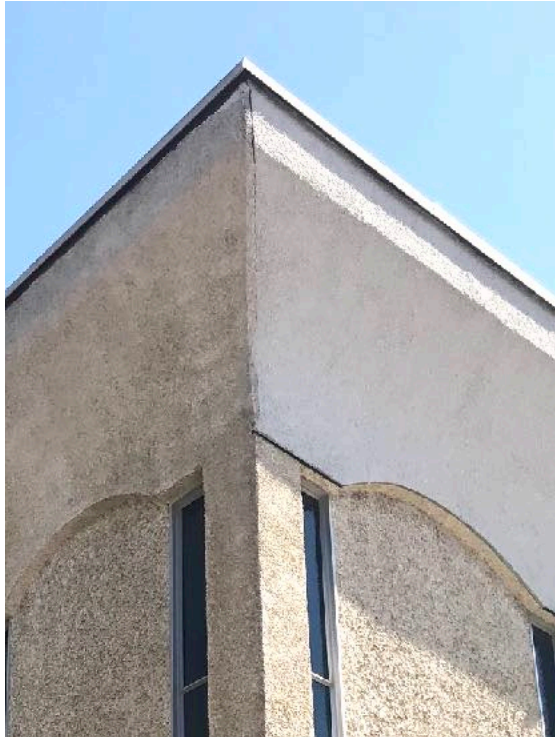
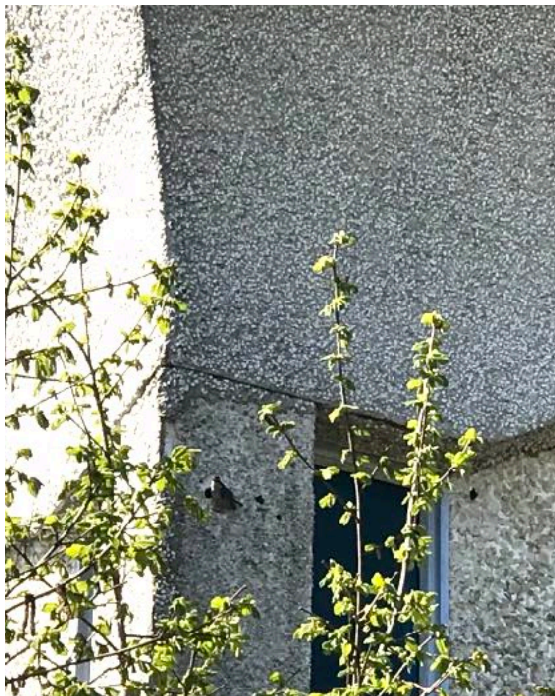
Stucco damage

Above left: Cornice at corner of parking lot and lane showing a crack in the stucco.

Above right: Cornice at corner of lane and yard showing missing/failing stucco just below an new roof drain installed 13 years ago. **Below left:** Cornice at corner of front and yard showing stucco damage caused by woodpeckers **below Right:** Evidence of moisture staining on stucco below windows at parking lot.

Address the sources of damage to the exterior stucco finish (woodpeckers and faulty roof drainage) and spot repair the stucco by matching the specific original texture. Trade hiring and repair supervision to be guided by a heritage professional.
