Heritage Conservation Plan

Holy Eucharist Cathedral - 501 4 Avenue - New Westminster, BC

Elana Zysblat, CAHP - heritage consultant - Ance Building Services

December 2021

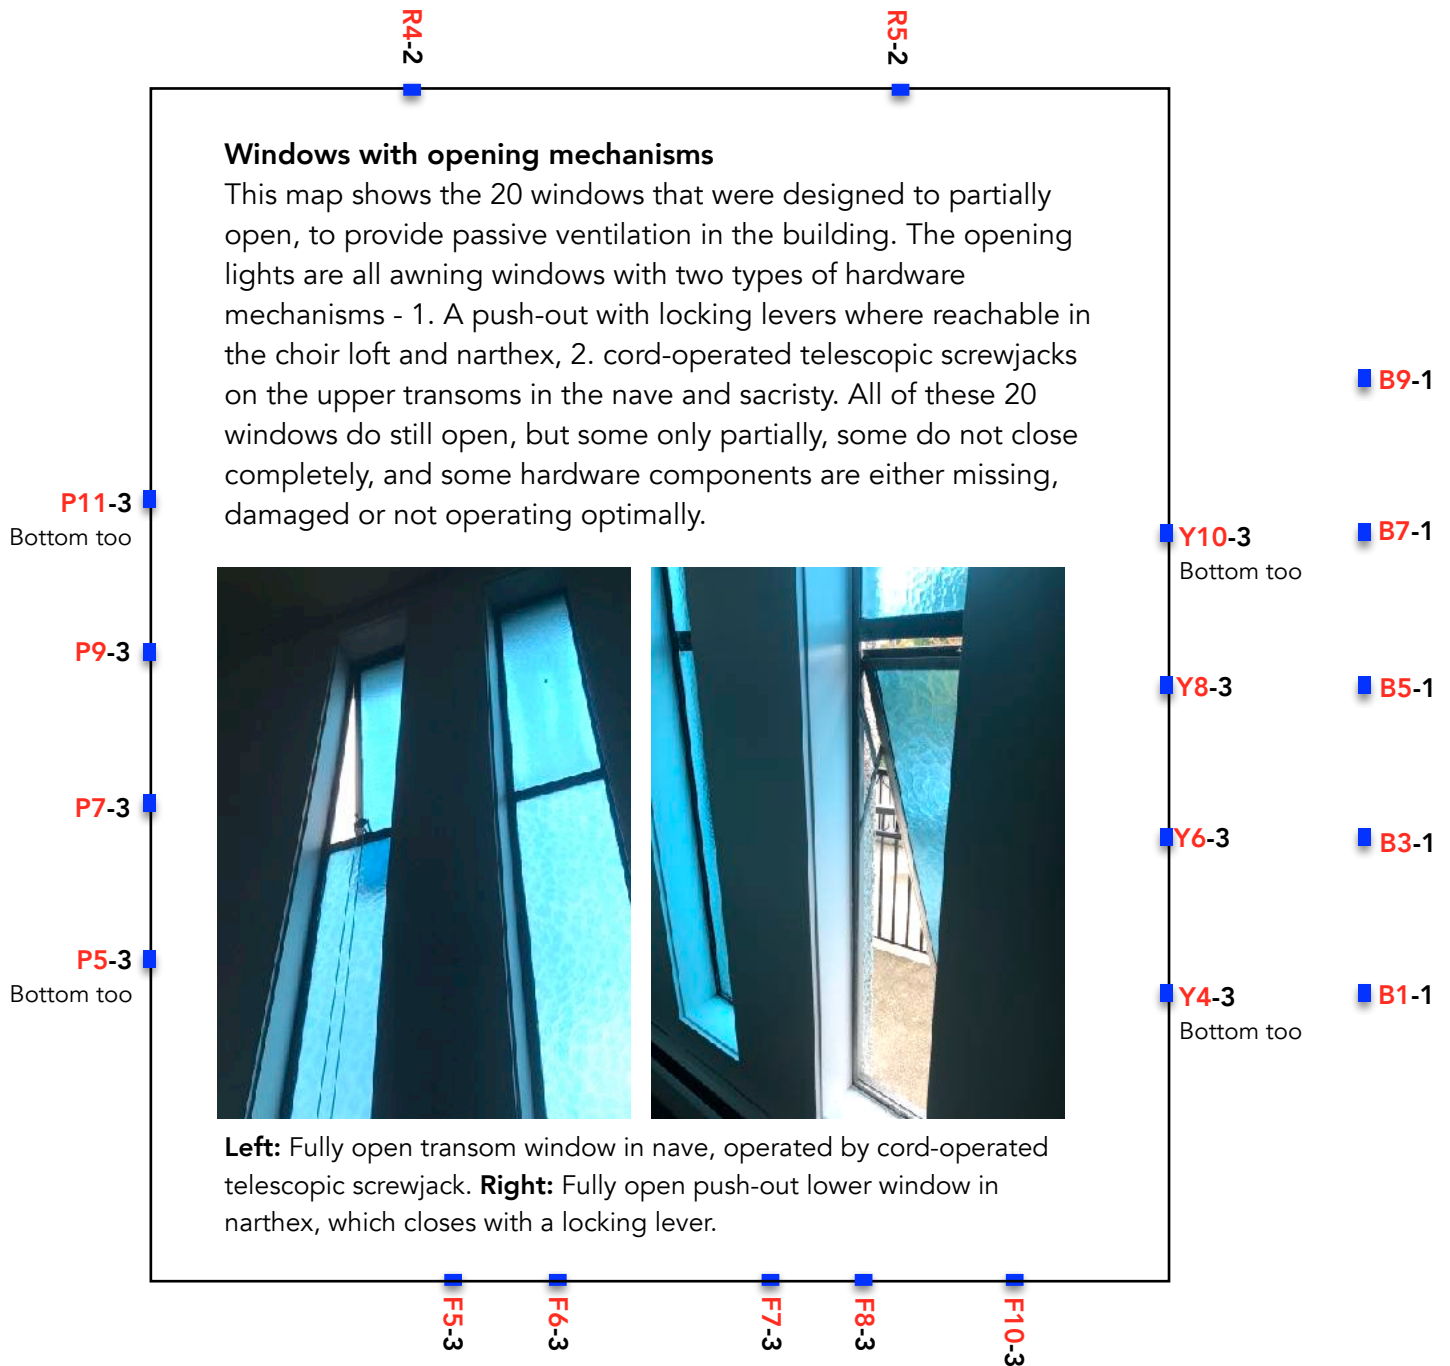
Cracked window panes:

The original design of facing upper and lower opening windows in the church was intended to enable passive (natural) ventilation in the church and needs to be used regularly and fully (both upper and lower lights) in the summer months. Replace broken window panes in-kind with

textured blue glass and restore the original opening and closing mechanisms of all opening windows to open fully, lock securely and be sealed properly when closed. All opening transom windows (upper windows) will need to be fitted with removable bird screens (ideally with transparent nylon netting to reduce aesthetic impact) to ensure that birds cannot fly into the church when the windows are open. Trade hiring and repair supervision to be guided by a heritage professional.
